1 ADOPTING the Madison-Kimbrough Blight Report and Redevelopment Plan  
2 for an area generally located along the west side of South  
3 Kimbrough Avenue north of East Madison Street at the  
4 intersection of these two streets. (The Land Clearance for  
5 Redevelopment Authority of the City of Springfield, Missouri, the  
6 Springfield Planning and Zoning Commission and City staff  
7 recommend approval.)  
8  
9  
10

This Blight Report for the Madison & Kimbrough Redevelopment Area (the “*Blight Study*”) is being submitted by BSH Springfield 1, LLC and Bryan Properties for the purpose of demonstrating that the Redevelopment Area (as defined below) should be declared blighted pursuant to the LCRA Law. This Blight Study will demonstrate (i) that the Redevelopment Area is a “blighted area” under the LCRA Law due to the predominance of deterioration of site improvements, insanitary and unsafe conditions, and the existence of conditions which endanger life and property by fire and other causes, and (ii) because of the aforementioned conditions, the Redevelopment Area constitutes an economic and social liability and a menace to the public health, safety, morals, and welfare in its pre

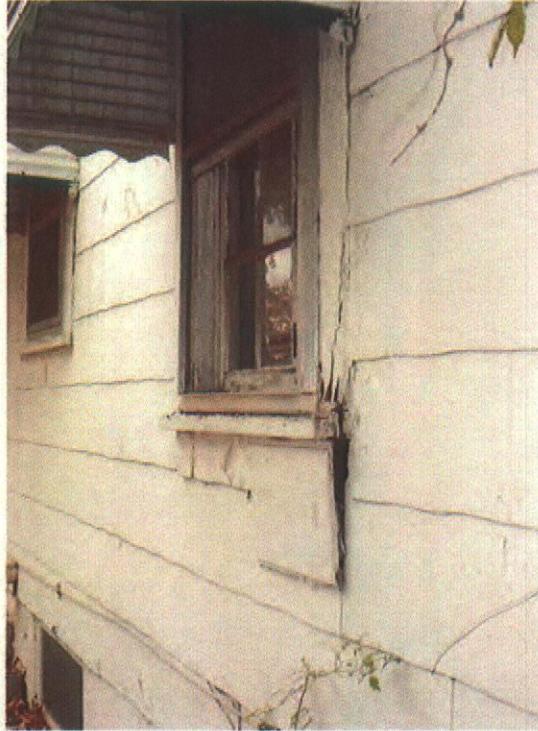
836 S. Roanoke Ave.  
South Side  
(See No. 4 on Figure 3 Map for  
location)

Peeling and loose fascia materials, rotting and splintering wood. – 1A

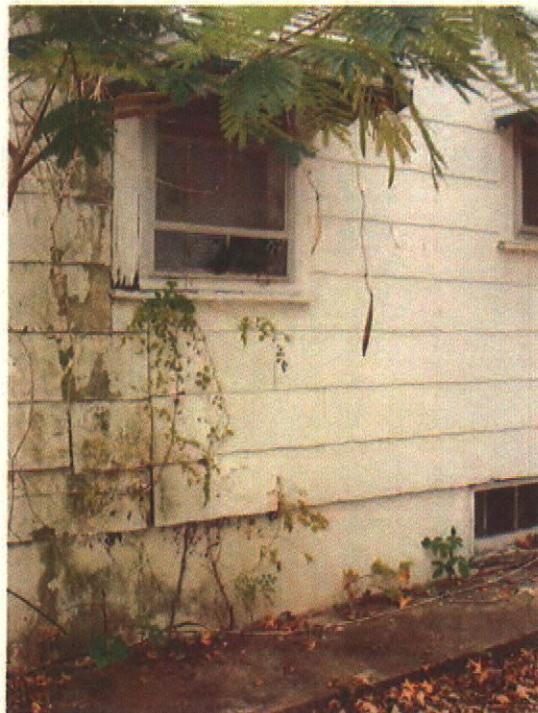
836 S. Roanoke Ave.  
South Side  
(See No. 4 on Figure 3 Map for  
location)

Misplaced wiring, peeling and warped fascia material,  
vegetation growing into siding, rotting wood, cracked foundation. – 1B

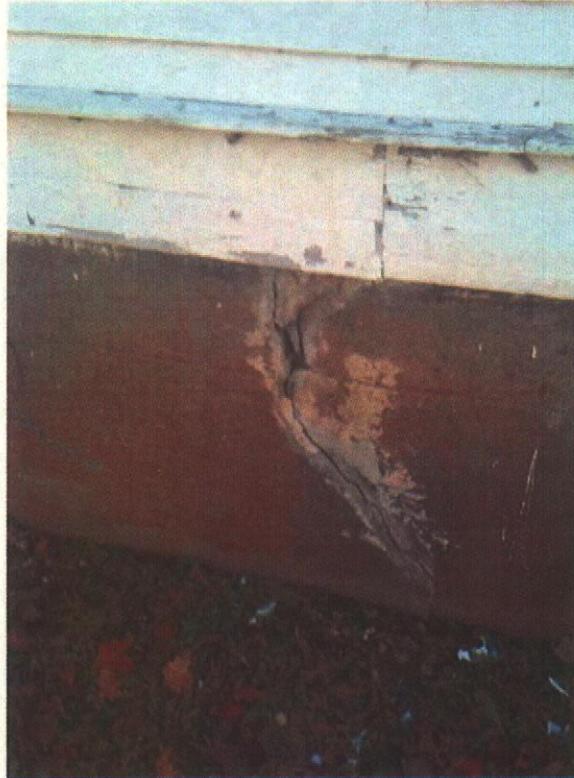
1C

**Cracked Foundation**

827 S. Kimbrough Ave.  
(See No. 13 on Figure 3  
Map for location)

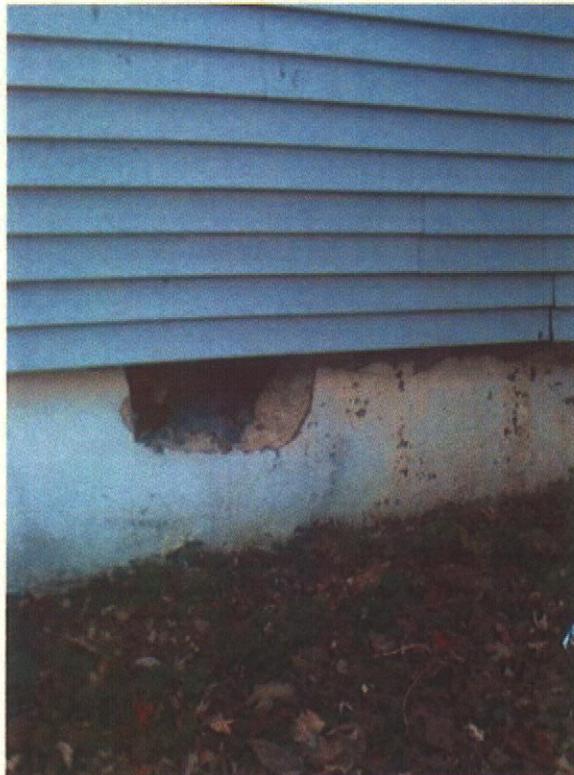
1D

840 S. Roanoke Ave.  
(See No. 5 on Figure 3 Map  
for location)

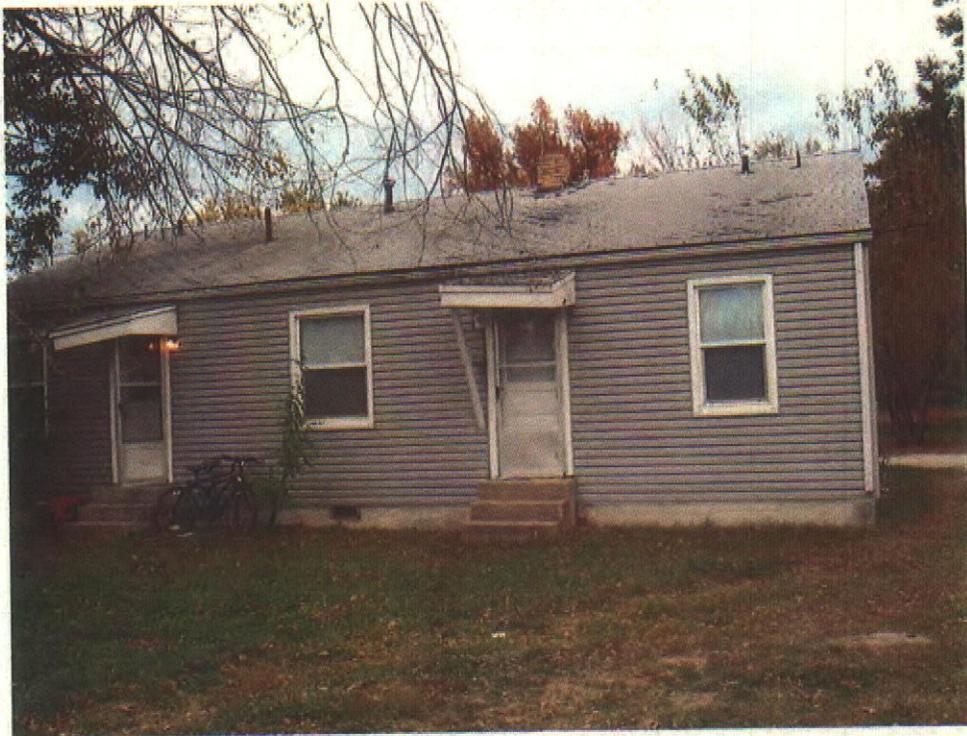
910 S. Roanoke Ave.  
North Side  
(See No. 8 on Figure 3  
Map for location)

Missing supports on awnings, warped shingles. – 1E

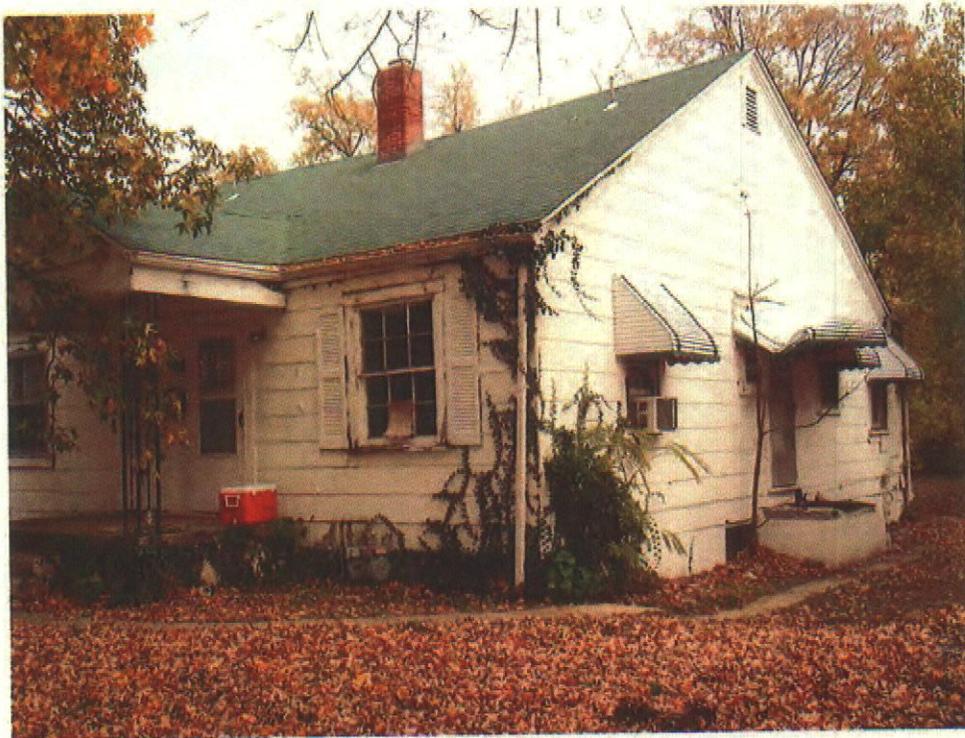
836 S. Roanoke Ave.  
Southwest Side  
(See No. 4 on Figure 3  
Map for location)

Broken and boarded up window panes, collapsed awning, peeling fascia materials. – 1F

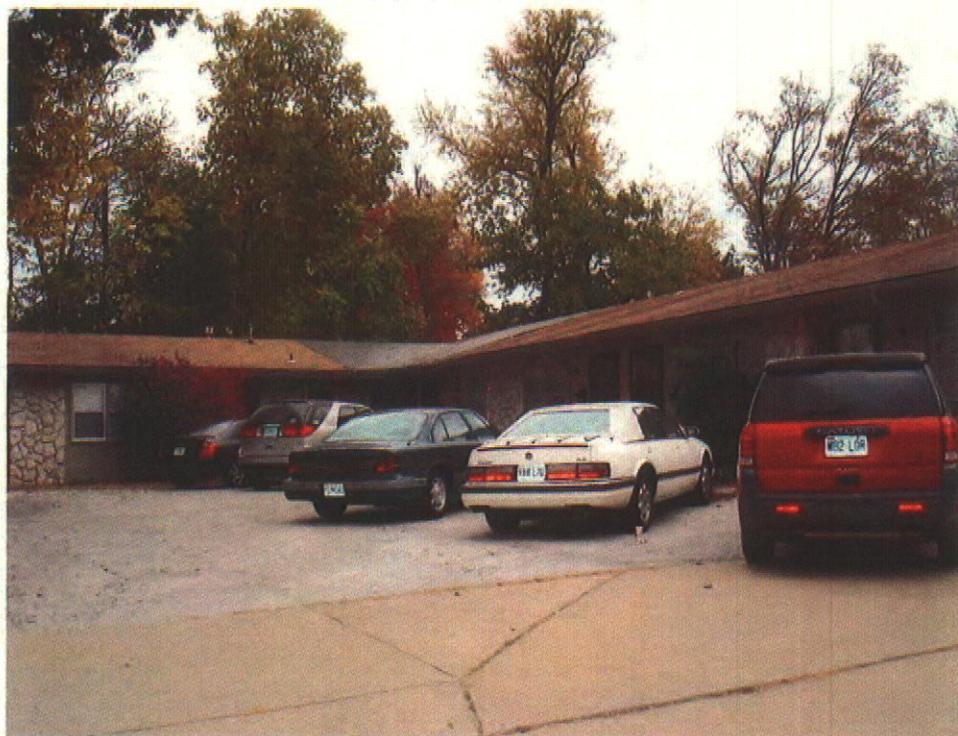
The Redevelopment Area as a whole suffers from deterioration. A large number of structures within the Redevelopment Area reveal deteriorated conditions to both primary and secondary building components. The deficiencies cannot be corrected through normal maintenance and require either renovation or replacement. Structural defects of many Buildings are so serious and extensive that they impair the safe use and occupancy of the Buildings. The remaining structures suffer from deferred maintenance of windows, doors, and exterior walls. Specifically, fascia materials are skewed, degraded, peeling, and warped. (Figures 1A, 1B, 1F, 1I, 1J, 1K, 1L, and 1Q). Masonry and concrete is chipped and crumbling, and many of the Buildings have cracked foundations. (Figures 1B, 1C, 1D, 1H, 1L, and 1Q). Much of the exterior wood is rotting and splintered, and there is evidence of water damage and possible mold. (Figures 1A, 1B, 1I, 1J, and 1Q). Window panes are missing and many windows are boarded closed. (Figures 1F, 1J, and 1P). The paint on the interior and exterior of the structures is peeling and chipped. (Figures 1A through 1P). On some of the Buildings, the gutters are loose or bent, shingles are beginning to deteriorate, and awnings are beginning to collapse. (Figures 1E, 1F, 1G, 1H, 1K, and 1L). Additionally, the roof on one of the larger Buildings was damaged in a storm and is currently patched with a tarp. (Figure 1G).

820 S. Roanoke Ave.  
North Side  
(See No. 1 on Figure 3  
Map for location)

**Damaged roof repaired with tarp. – 1G**

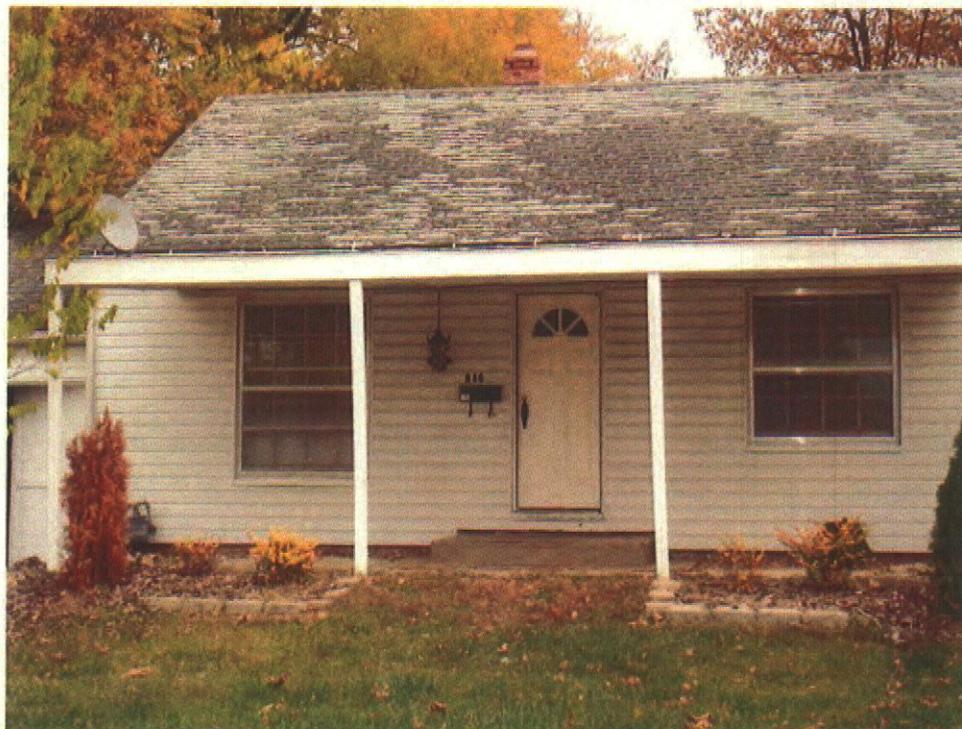
846 S. Roanoke Ave.  
West Side  
(See No. 6 on Figure 3  
Map for location)

**Deteriorating shingles, cracked concrete,  
mortar crumbling and missing between chimney bricks. – 1H**

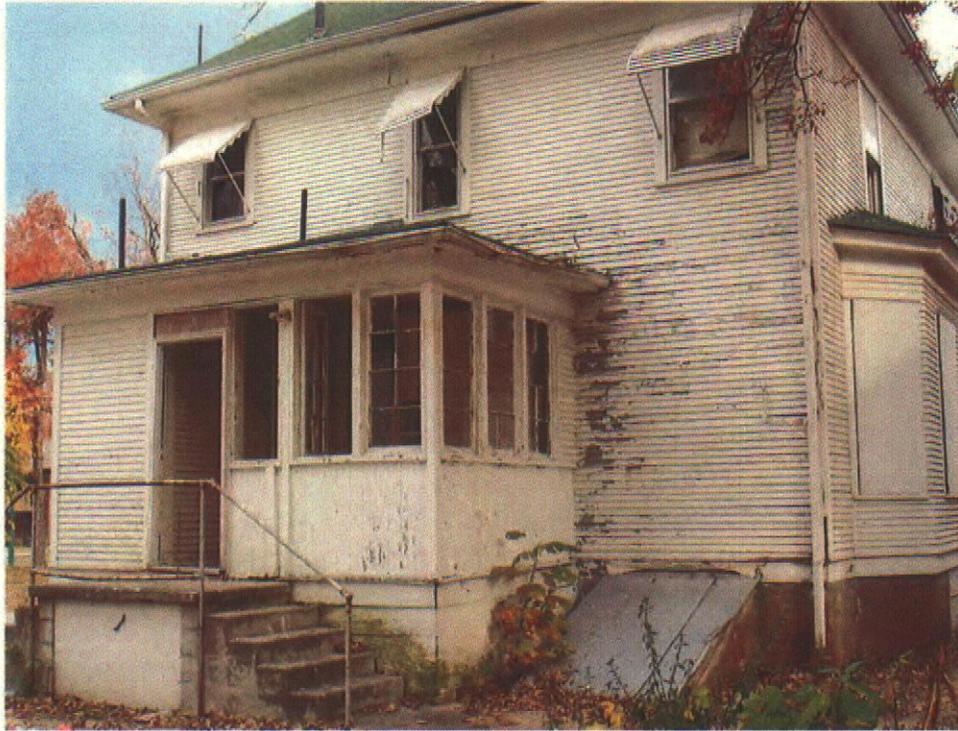
11

Damaged gutters, warped and peeling fascia materials, rotting wood.

827 S. Kimbrough Ave.  
East Side  
(See No. 13 on Figure 3 Map for location)

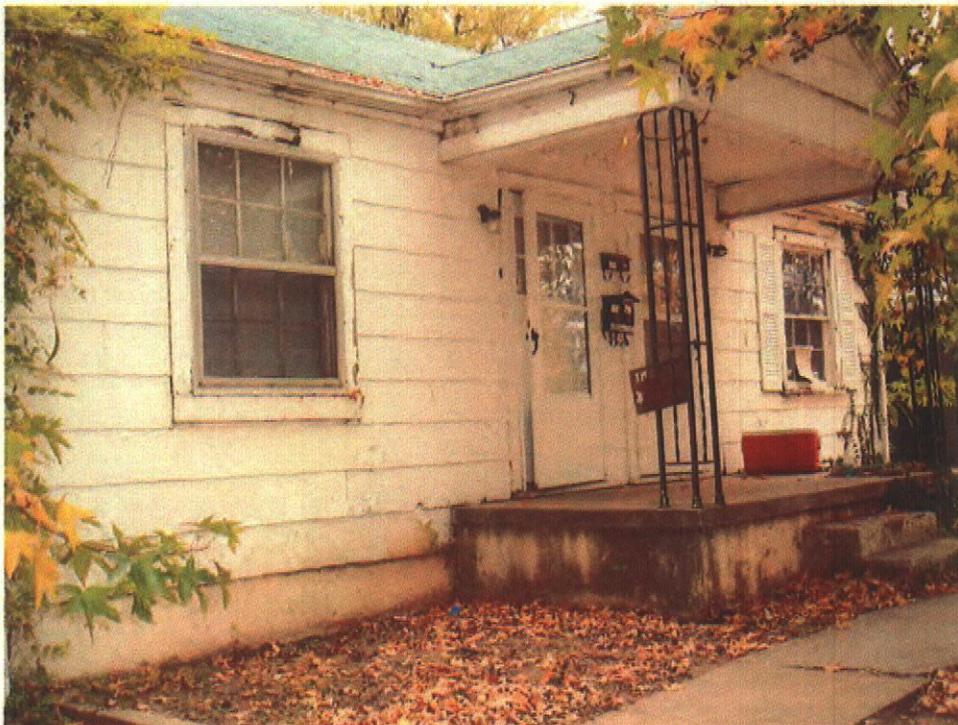
1J

836 S. Roanoke Ave.  
West Side  
(See No. 4 on Figure 3 Map for location)

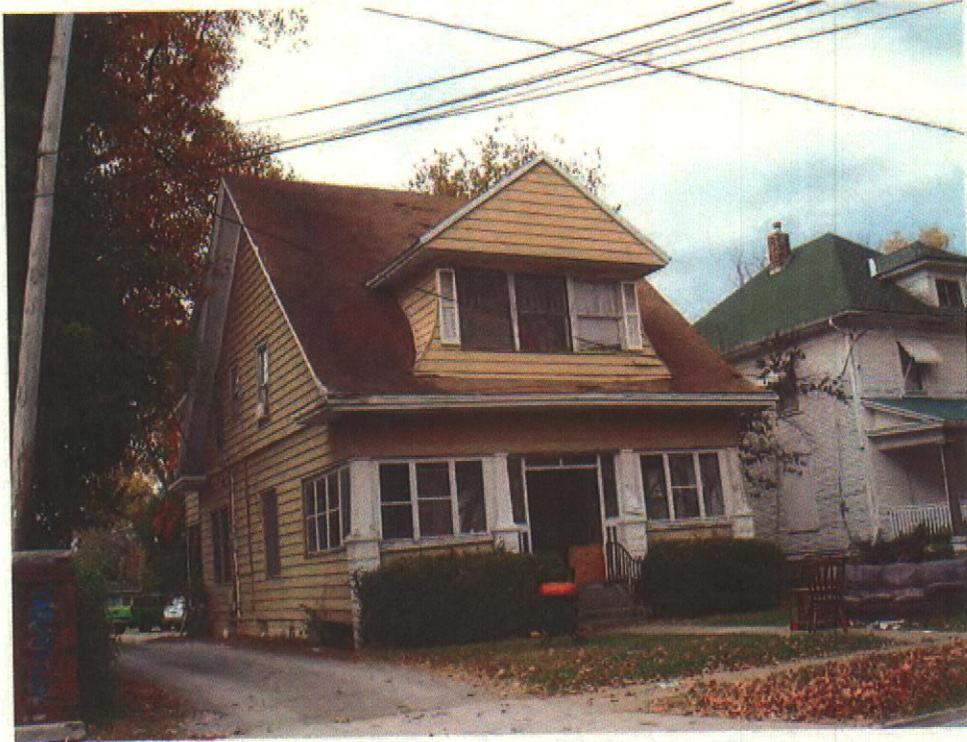
Other types of site improvements in the Redevelopment Area also exhibit deteriorated conditions. Pavement and concrete surfaces including parking areas, sidewalks, and curbs are cracked, crumbling, uneven, or otherwise dilapidated. (Figures 1G, 1J, and 1R). The Redevelopment Area also suffers from the presence of debris and refuse, which deleterious conditions have not been remedied, evidencing a general lack of maintenance. (Figures 1K and 1L).

Deteriorating and missing shingles, cracked concrete, peeling paint, garbage.

831 S. Kimbrough Ave.  
East Side  
(See No. 12 on Figure 3 Map for location)

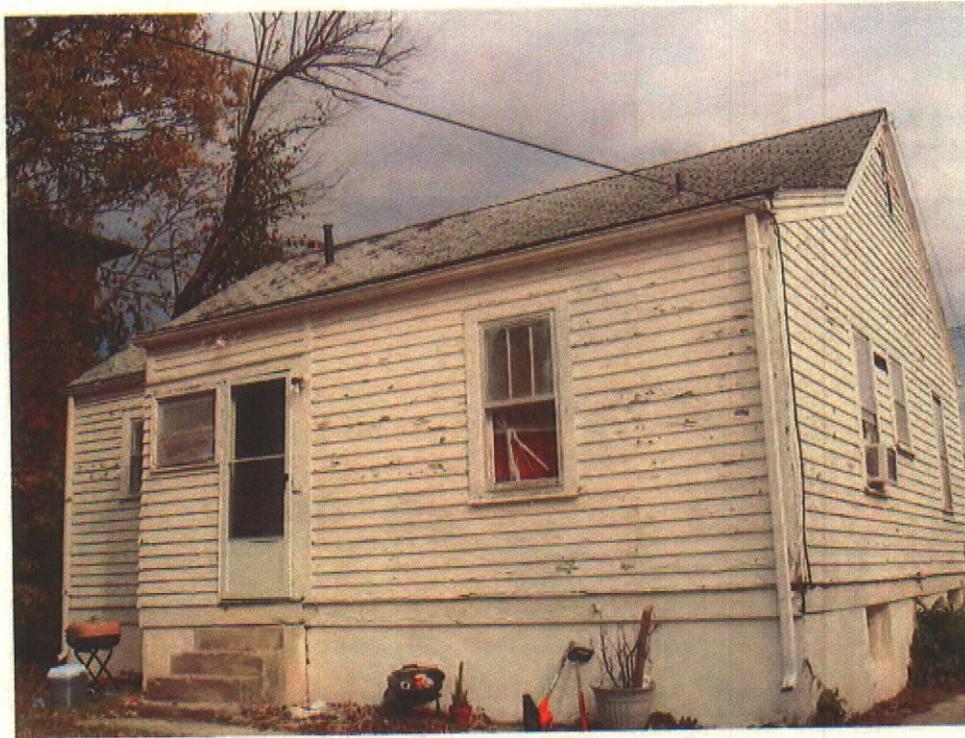
1L

911 S. Kimbrough Ave.  
West Side  
(See No. 10 on Figure 3 Map for location)

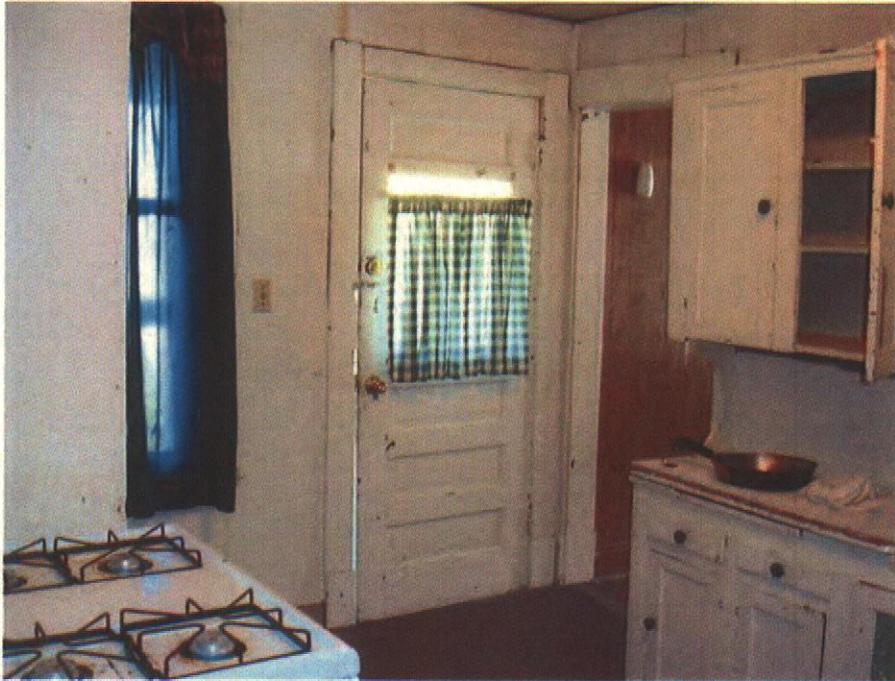
1M

Peeling paint and drywall damage.

525 E. Madison St.  
Upstairs Apartment  
(See No. 15 on Figure 3  
Map for location)

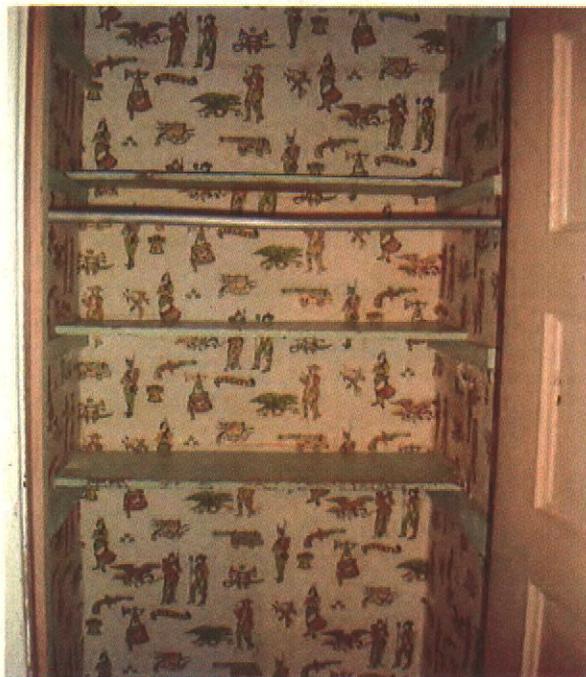
1N

525 E. Madison St.  
Upstairs Apartment  
(See No. 15 on Figure 3  
Map for location)

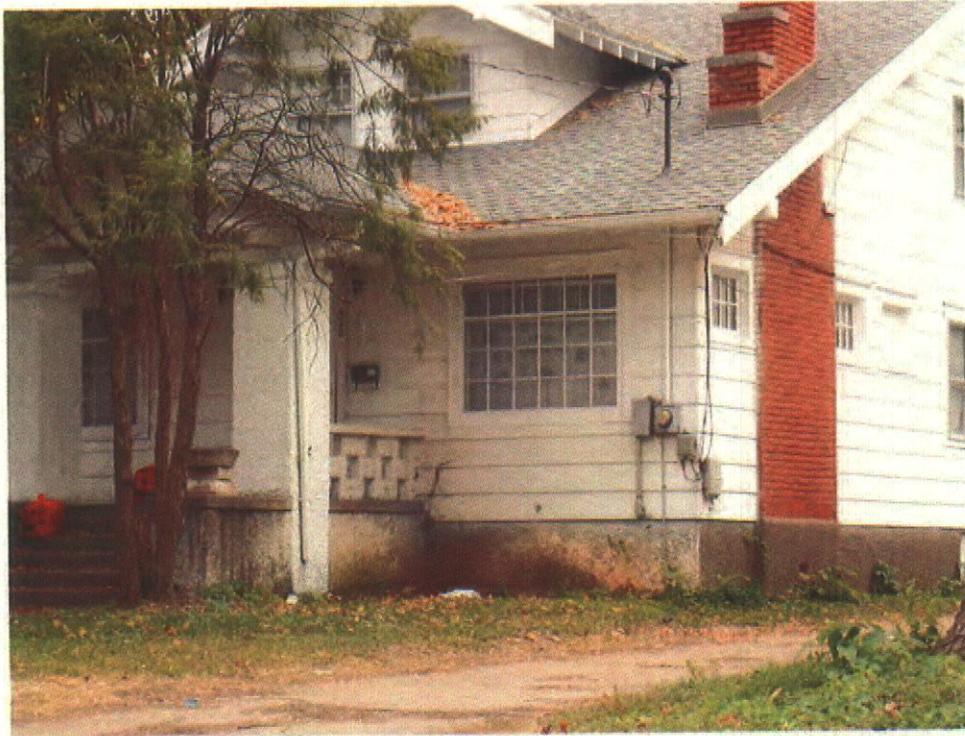
Deterioration also includes lack of maintenance and upkeep to the landscaped areas. The Redevelopment Area lacks any provisions for the maintenance and upkeep of landscaping amenities. It exhibits an overgrowth of vegetation, and noxious weeds have infested many areas. (Figures 1S, 1T, 1U, 1V, and 1W). Plants are growing into the siding on some of the Buildings, and trees are growing into power lines. (Figures 1B, 1O, 1P, and 1S).

520 E. Madison St.  
North Side  
(See No. 14 on Figure  
3 Map for location)

Tree growing into power lines. – 10

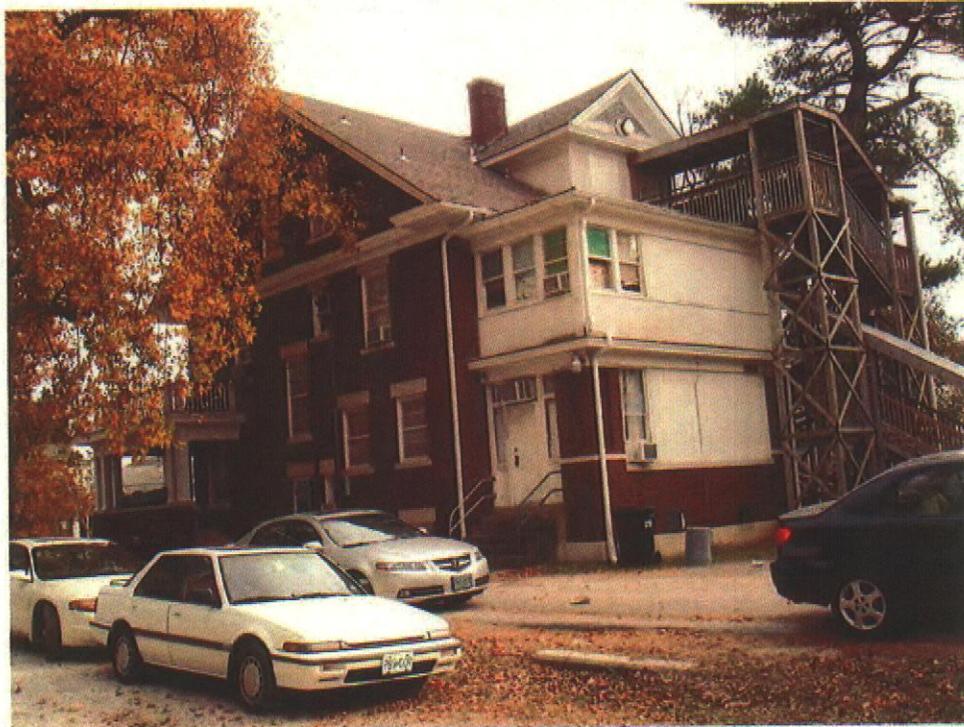
835 S. Kimbrough  
Ave.  
Northwest Side  
(See No. 11 on Figure  
3 Map for location)

Missing and broken window panes, boarded up windows, tree growing into power line. – 1P

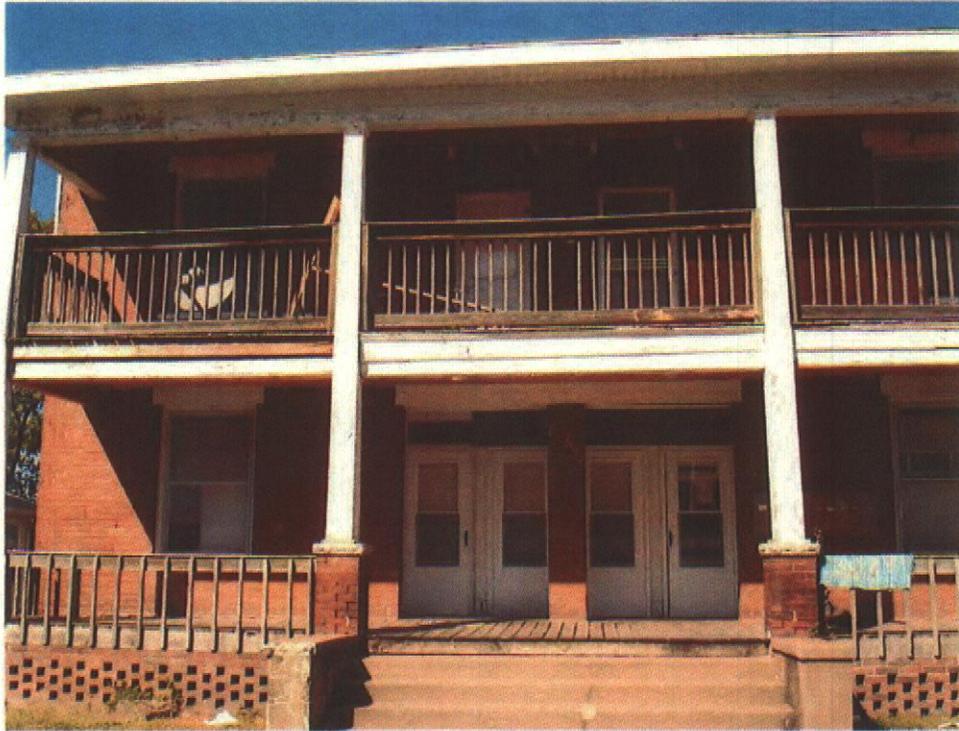
1Q

Chipped and cracked concrete, splintering wood, missing fascia boards, peeling paint.

525 E. Madison St.  
South Side  
(See No. 15 on Figure  
3 Map for location)

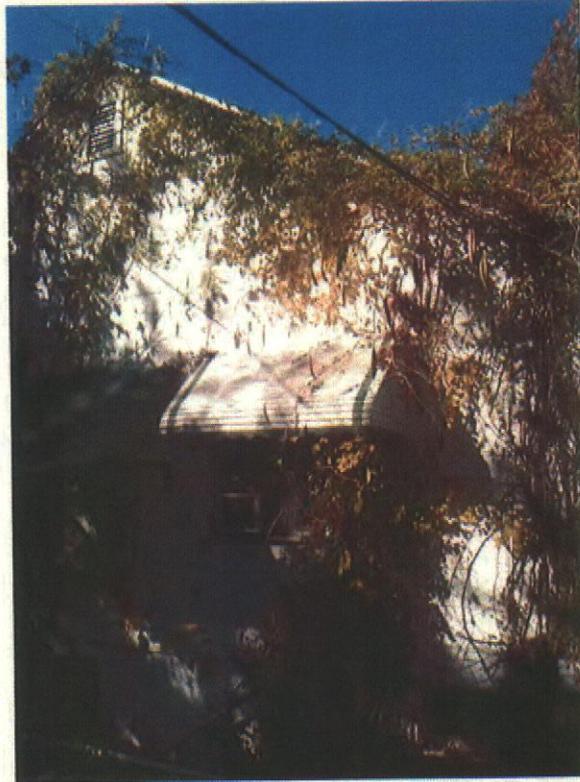
1S

Overgrowth of vegetation and weeds and trees in power line.

834 S. Roanoke Ave.  
South Side  
(See No. 3 on Figure 3 Map  
for location)

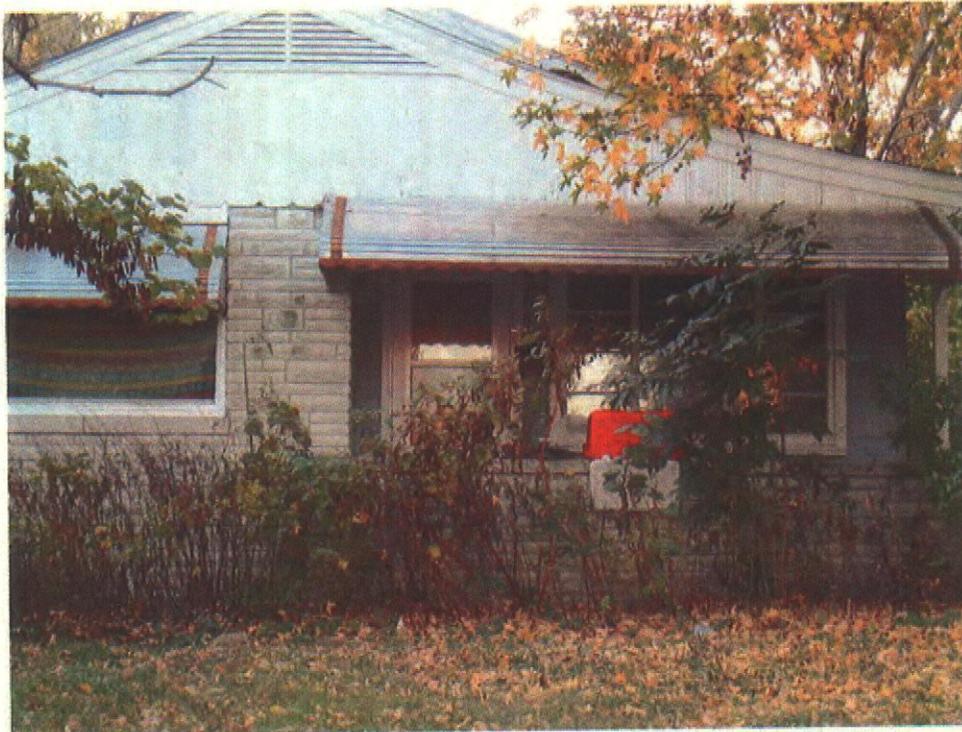
832 S. Roanoke  
Ave.  
West Side  
(See No. 2 on Figure  
3 Map for location)

Overgrowth of vegetation and weeds – 1T

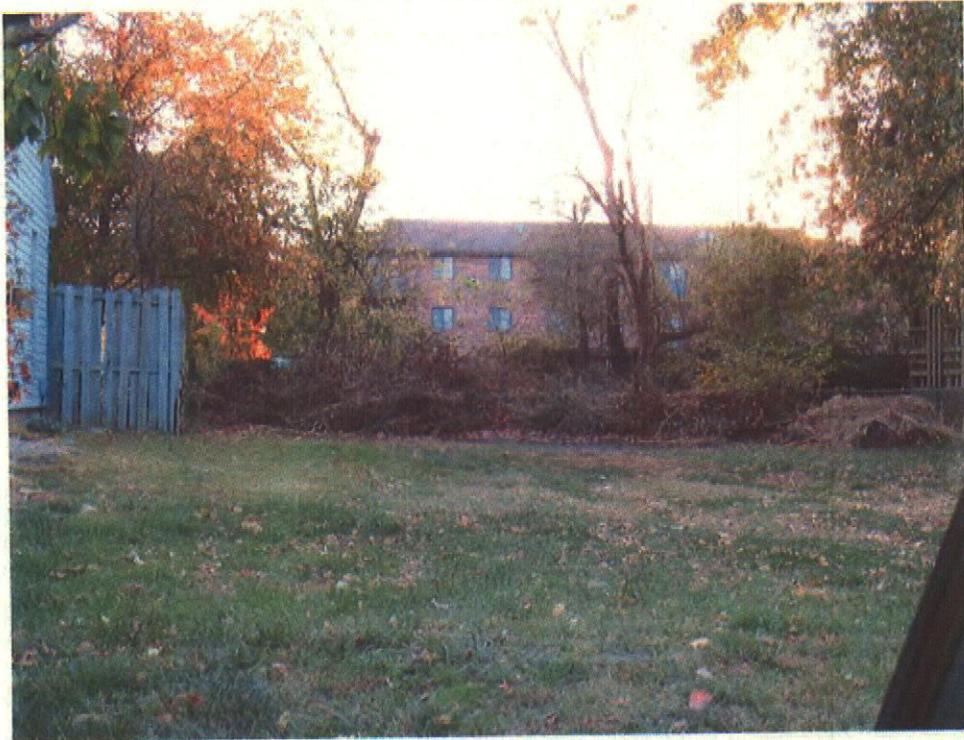
1U

**Figure 1 Continued**  
Overgrowth of vegetation and weeds.

Lot adjacent to 846  
S. Roanoke Ave. and  
behind 909 S.  
Kimbrough Ave.  
(See No. 7 on Figure 3  
Map for location)

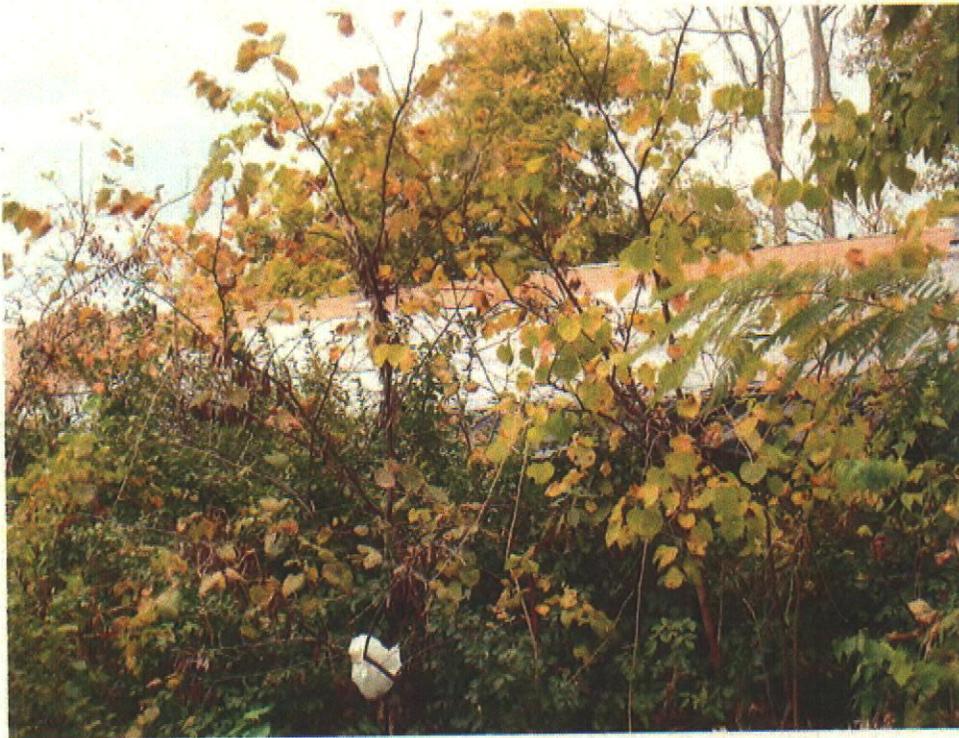
1V

820 S. Roanoke Ave.  
South Side  
(See No. 1 on Figure 3  
Map for location)

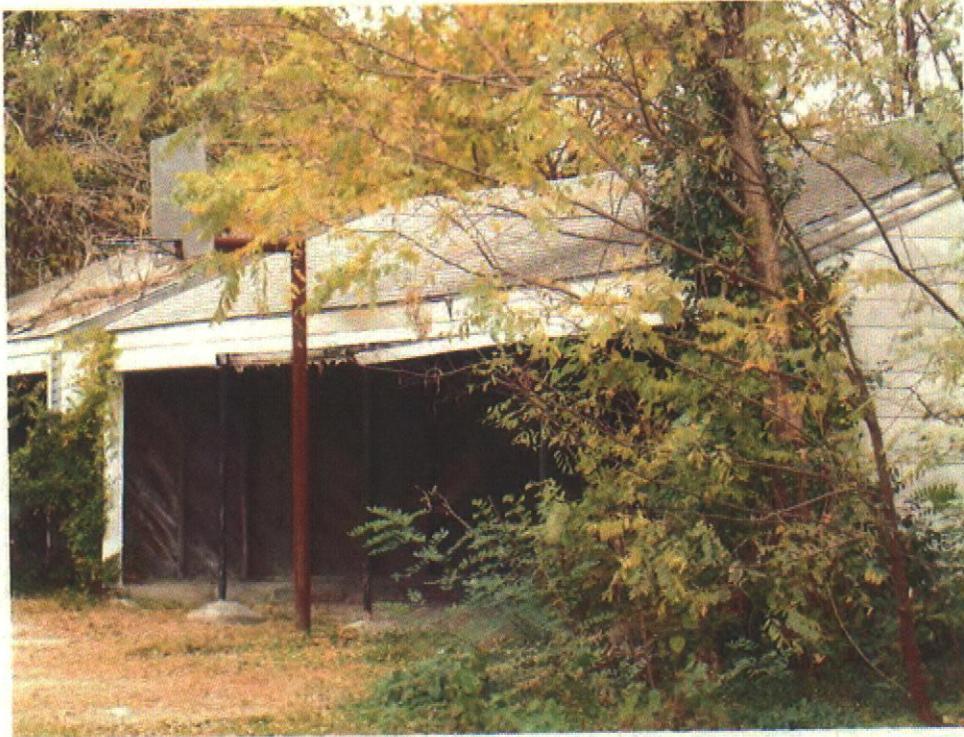
1W

**Figure 1 Continued**  
**Overgrowth of vegetation and weeds.**

832-834 S. Roanoke  
Ave.  
Garage  
(See No. 3 on Figure 3  
Map for location)

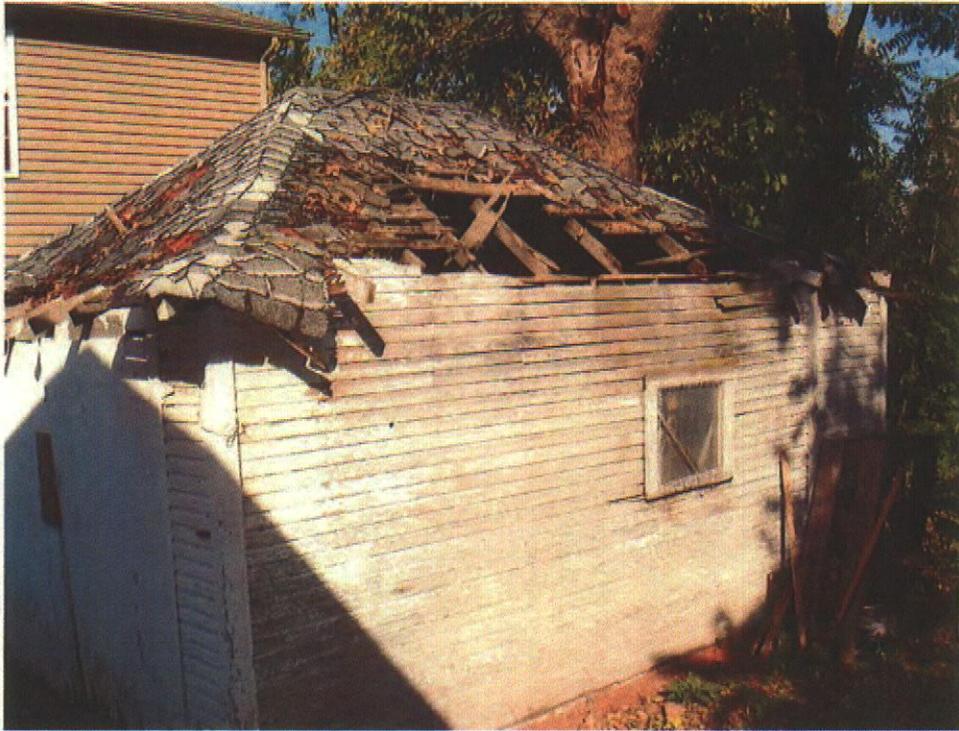
519 E. Madison St.  
Garage  
(See No. 16 on Figure  
3 Map for location)

**Collapsed Roof. - 2A**

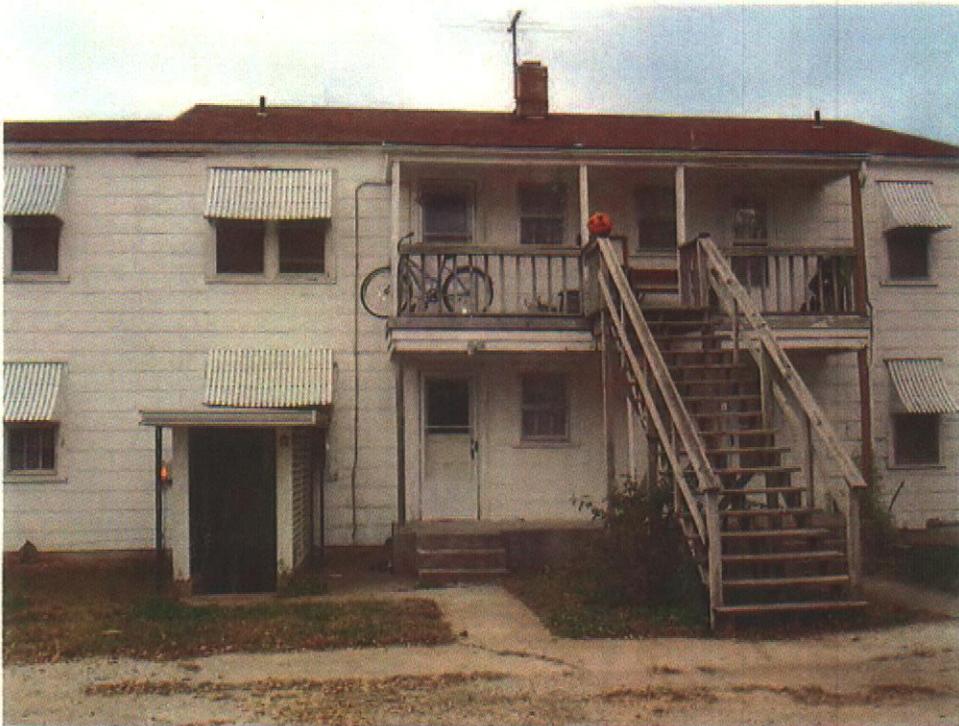
There are a variety of factors which contribute to the unsafe conditions that are present in the Redevelopment Area. Many of the outdated mechanical systems in the Buildings are unsafe, especially with respect to electrical and fire prevention systems. Furthermore, the wiring in several of the Buildings, much of which is loose and exposed, is also outdated and in need of repair. (Figures 2E, 2F, and 2H). Hazardous conditions include sagging floors and caved in roofs. (Figures 2B and 2G). Additionally, the condition of the sidewalks in this pedestrian environment is also unsafe and warrants immediate attention as treacherous conditions may be caused by the combination of standing water or precipitation and the soon to be winter weather. (Figure 2B).

920 S. Roanoke Ave.  
East Side  
(See No. 9 on Figure 3  
Map for location)

**Unsafe sidewalk conditions. - 2B**

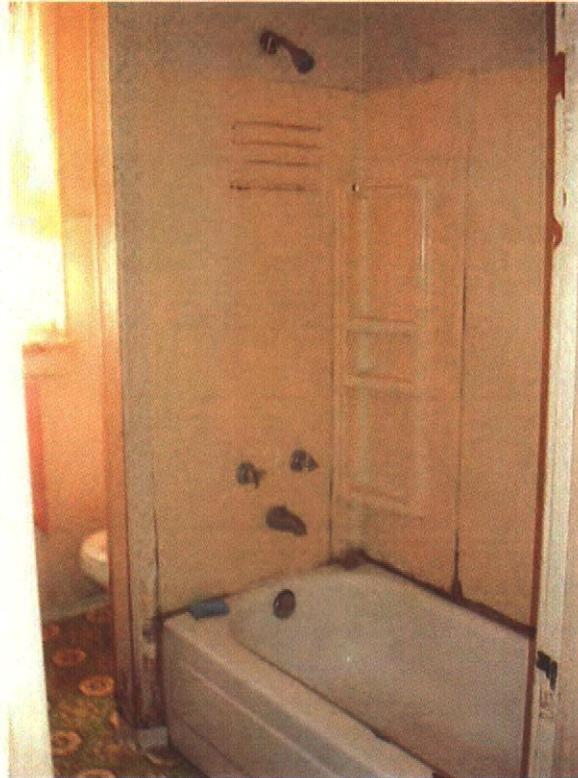
Water damage caused by leaks and flooding is present throughout the interior of the Buildings contributing to the presence of mold and rotting wood. (Figures 2C and 2D). Mold is also growing around kitchen sinks, bathroom sinks, and bathtubs. (Figures 2C, 2E, and 2F) Cabinets and shelves are filthy, and substantial portions of the Buildings have carpet which has significantly deteriorated and is imbedded with dirt and other grime. (Figures 2E, 2F, and 2I). The Buildings also host a variety of insects and spiders. (Figures 2E and 2F). Many of the Buildings are littered with a conglomeration of trash, debris, and junk, which further contributes to the insanitary conditions plaguing the Redevelopment Area. (Figures 2I, 2J, 2K, 2L, and 2M).

525 E. Madison St.  
Inside of Apartment  
(See No. 15 on Figure 3 Map for location)

**Mold and rotting wood. – 2C**

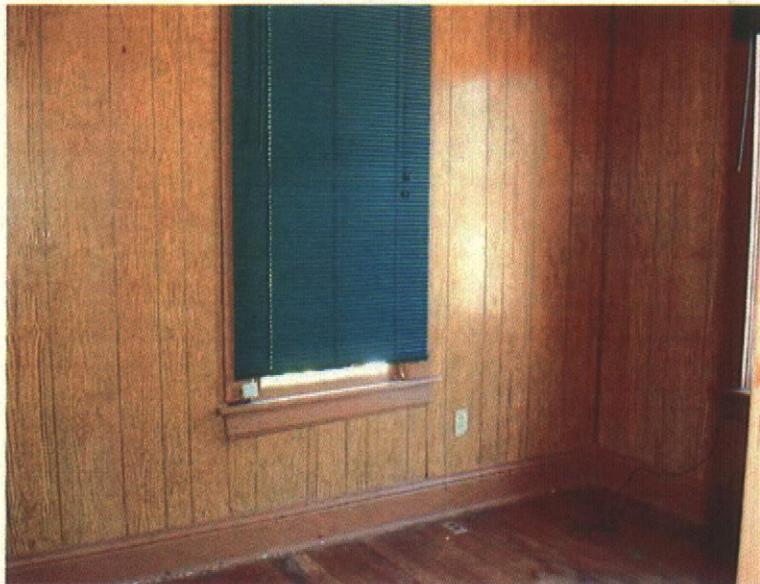
525 E. Madison St.  
Inside of Apartment  
(See No. 15 on Figure 3 Map for location)

**Water damage to floors. – 2D**

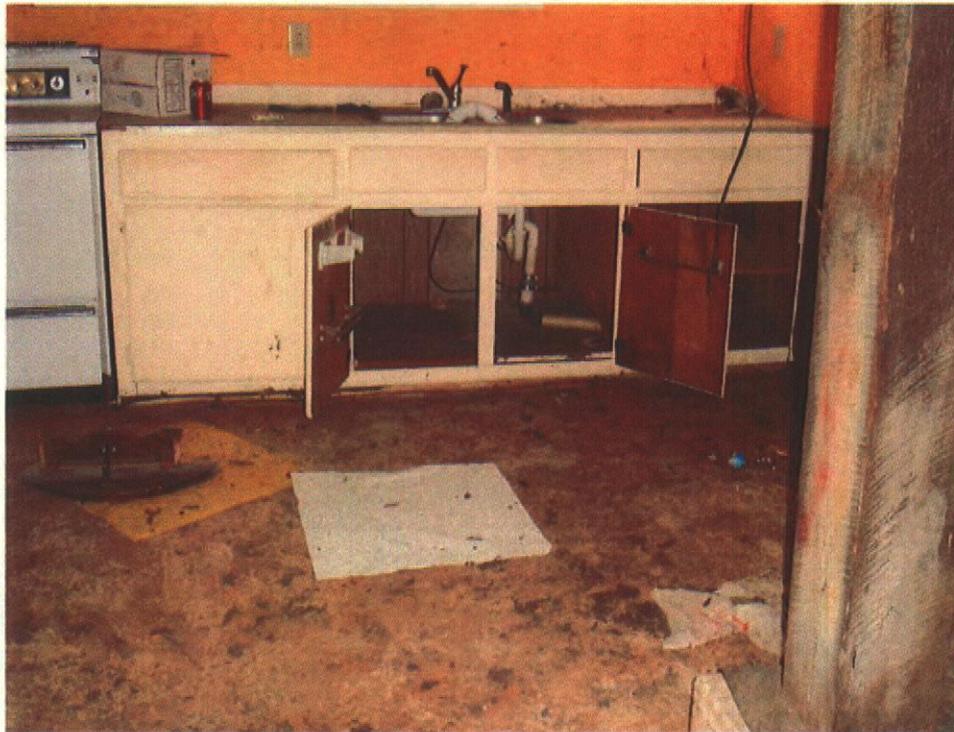
2E

Mold, filth, loose wires, and insects.

836 S. Roanoke Ave.  
Basement Apartment  
(See No. 4 on Figure 3  
Map for location)

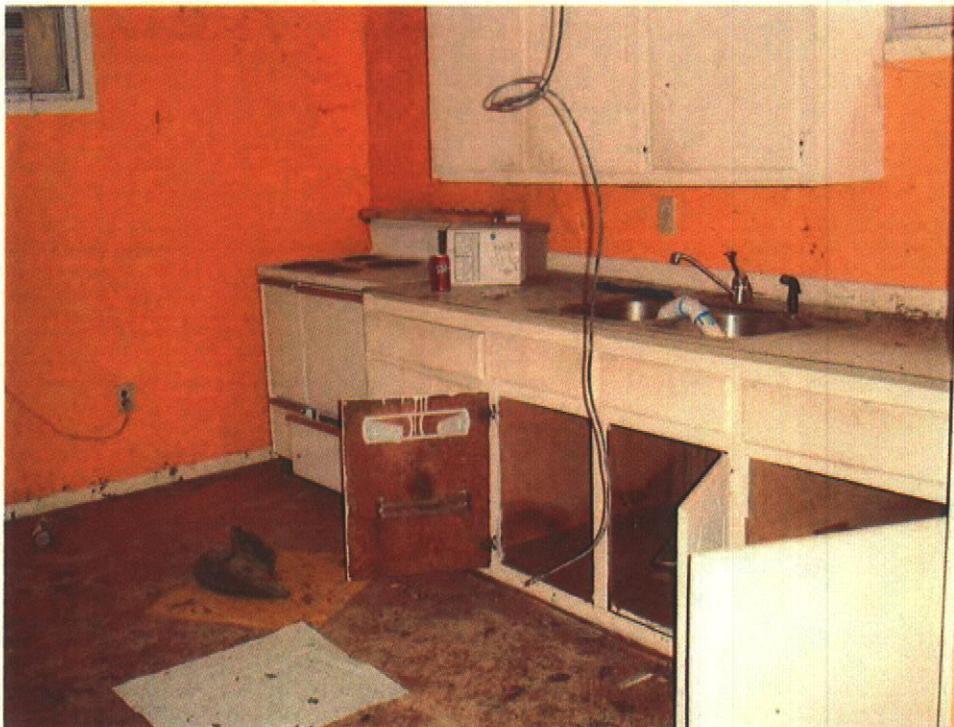
2F

836 S. Roanoke Ave.  
Basement Apartment  
(See No. 4 on Figure 3  
Map for location)

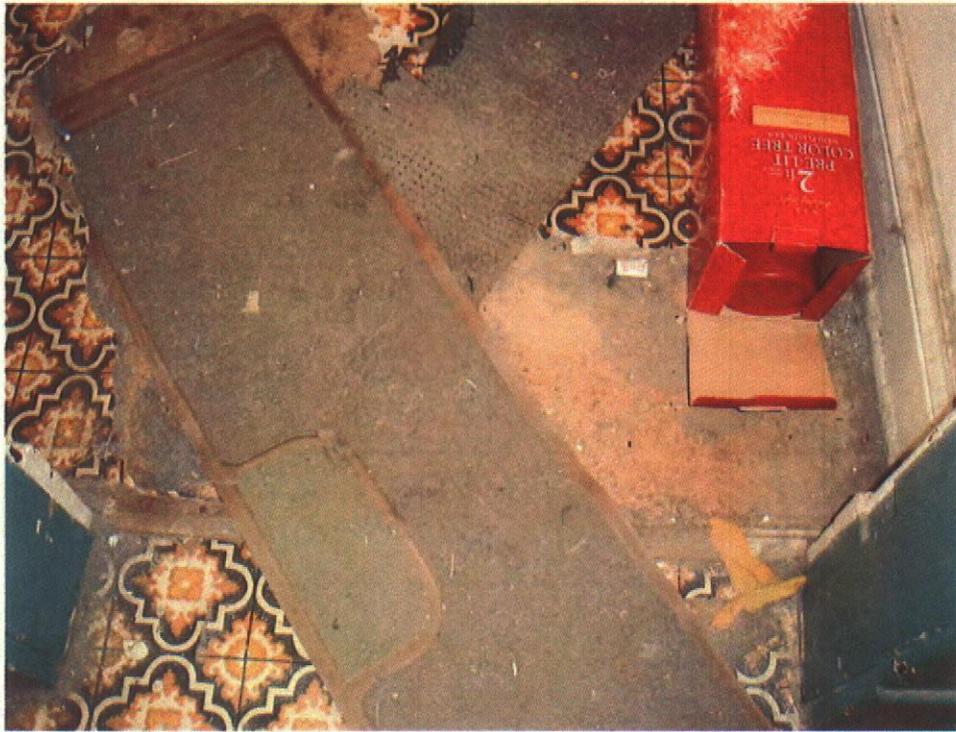
525 E. Madison St.  
Upstairs Apartment  
(See No. 15 on Figure  
3 Map for location)

**Sagging floors, dirt and debris. – 2G**

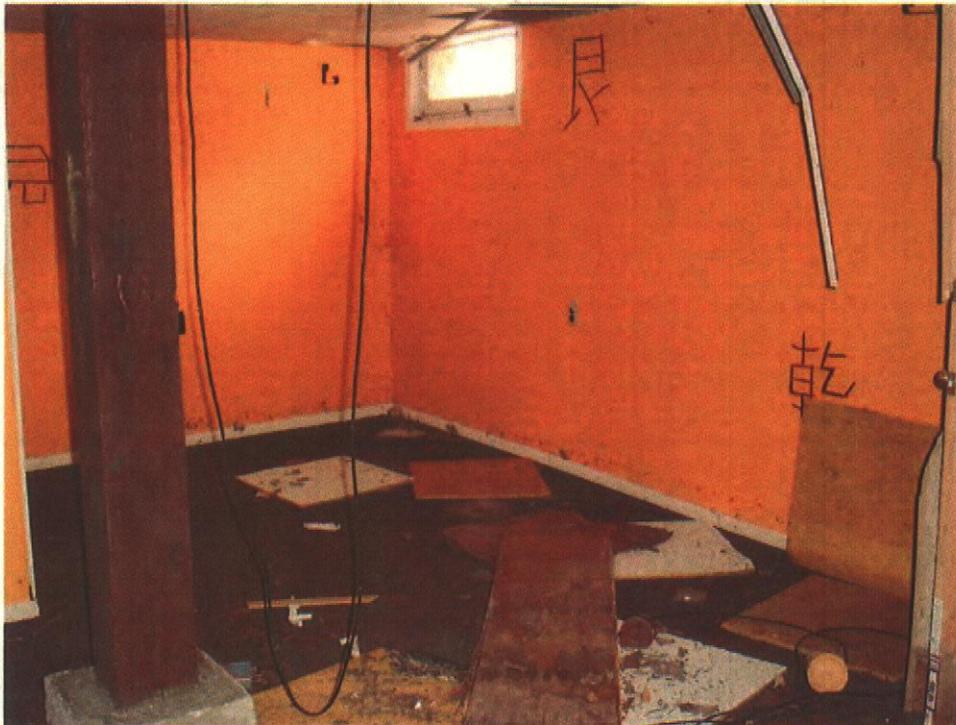
836 S. Roanoke Ave.  
Basement Apartment  
(See No. 4 on Figure 3  
Map for location)

**Loose wiring and debris. – 2H**

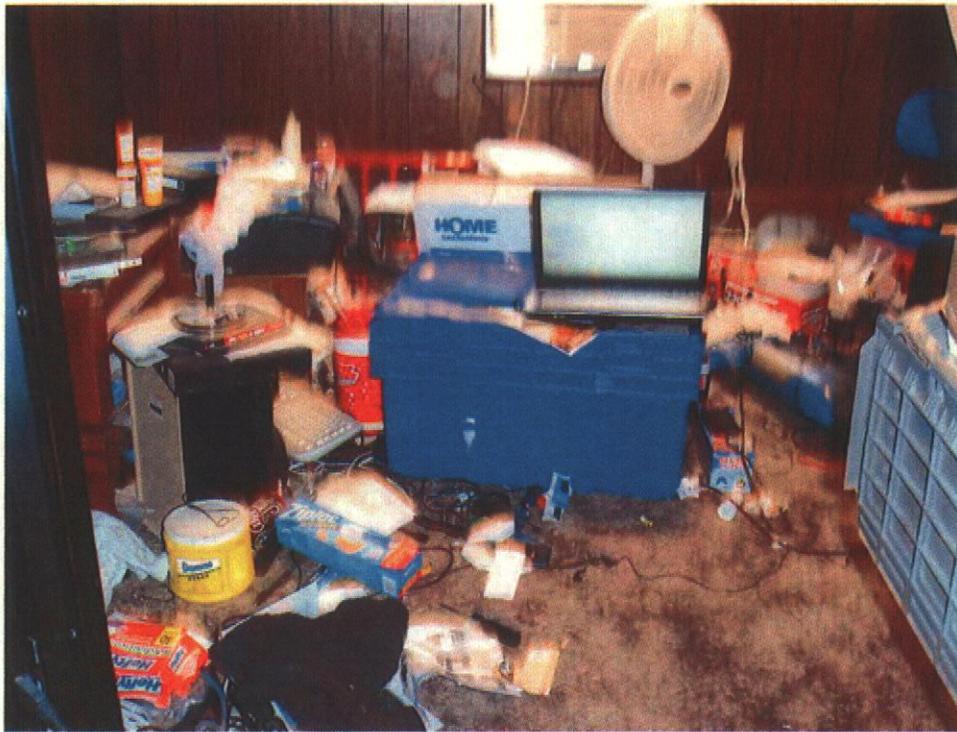
2I

**Figure 2 Continued**  
Trash, junk, and other filth.

525 E. Madison St.  
Upstairs Apartment  
(See No. 15 on Figure 3  
Map for location)

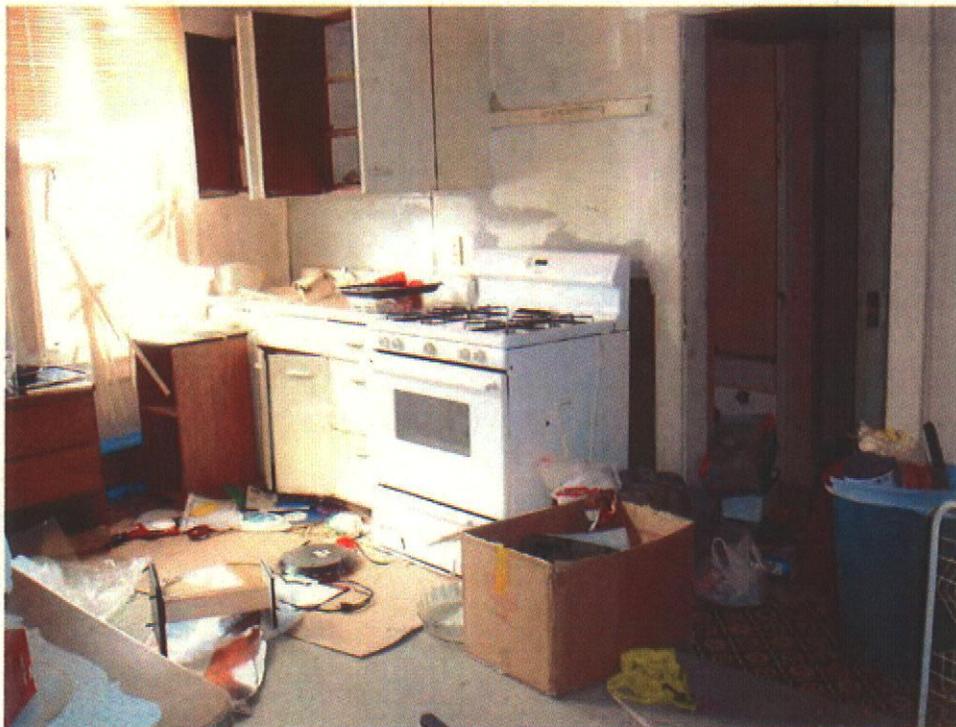
2J

525 E. Madison St.  
First Floor Apartment  
(See No. 15 on Figure 3  
Map for location)
