1 ADOPTING the Madison-Kimbrough Blight Report and Redevelopment Plan  
2 for an area generally located along the west side of South  
3 Kimbrough Avenue north of East Madison Street at the  
4 intersection of these two streets. (The Land Clearance for  
5 Redevelopment Authority of the City of Springfield, Missouri, the  
6 Springfield Planning and Zoning Commission and City staff  
7 recommend approval.)  
8  
9  
10

This Blight Report for the Madison & Kimbrough Redevelopment Area (the “*Blight Study*”) is being submitted by BSH Springfield 1, LLC and Bryan Properties for the purpose of demonstrating that the Redevelopment Area (as defined below) should be declared blighted pursuant to the LCRA Law. This Blight Study will demonstrate (i) that the Redevelopment Area is a “blighted area” under the LCRA Law due to the predominance of deterioration of site improvements, insanitary and unsafe conditions, and the existence of conditions which endanger life and property by fire and other causes, and (ii) because of the aforementioned conditions, the Redevelopment Area constitutes an economic and social liability and a menace to the public health, safety, morals, and welfare in its pre

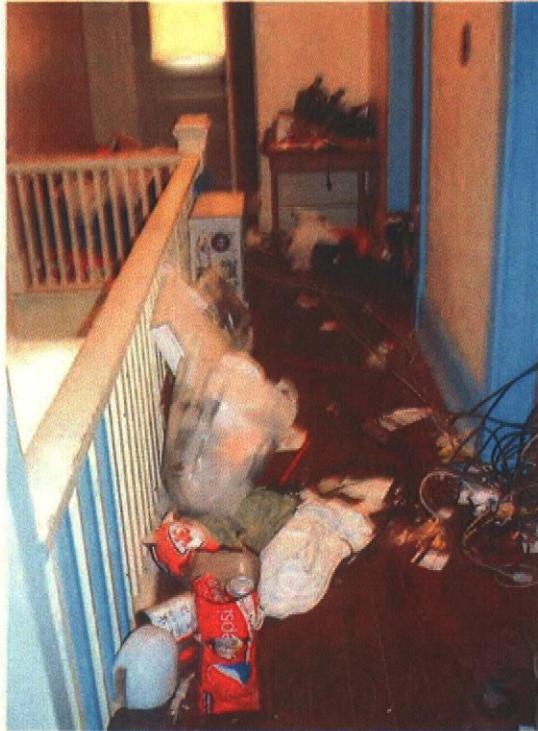
2K

Water damage caused by leaks and flooding is present throughout the interior of the Buildings contributing to the presence of mold and rotting wood. (Figures 2C and 2D). Mold is also growing around kitchen sinks, bathroom sinks, and bathtubs. (Figures 2C, 2E, and 2F) Cabinets and shelves are filthy, and substantial portions of the Buildings have carpet which has significantly deteriorated and is imbedded with dirt and other grime. (Figures 2E, 2F, and 2I). The Buildings also host a variety of insects and spiders. (Figures 2E and 2F). Many of the Buildings are littered with a conglomeration of trash, debris, and junk, which further contributes to the insanitary conditions plaguing the Redevelopment Area. (Figures 2I, 2J, 2K, 2L, and 2M).

**Figure 2 Continued**  
Trash, junk, and other filth.

525 E. Madison St.  
Upstairs Hallway  
(See No. 15 on Figure 3 Map  
for location)

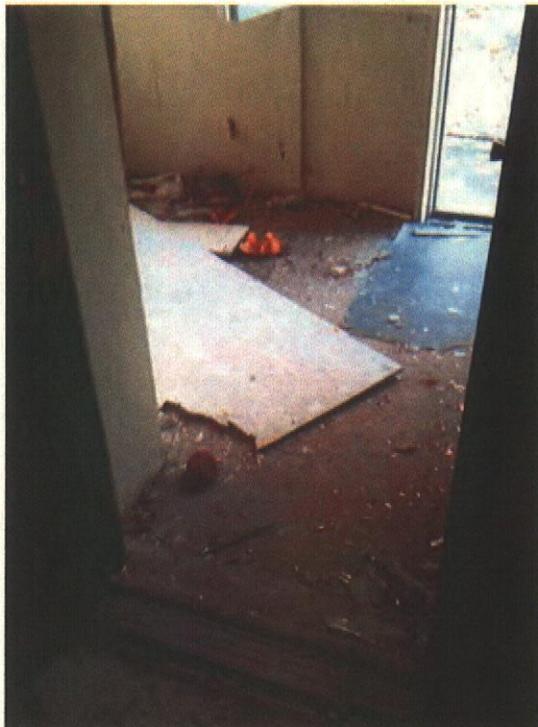
2L

827 S. Kimbrough Ave.  
First Floor Apartment  
(See No. 13 on Figure 3  
Map for location)

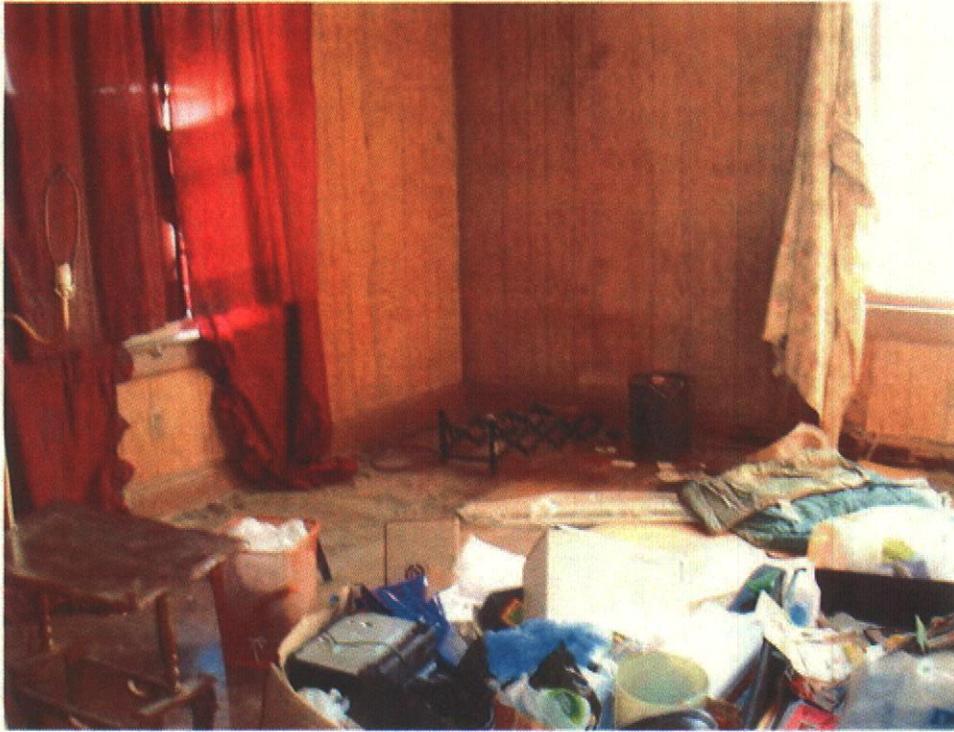
2M

525 E. Madison St  
First Floor  
Apartment  
(See No. 15 on  
Figure 3 Map for  
location)
